ATOS Safety Notice

All models with carbon control frame and no nose wires

5 May 2004

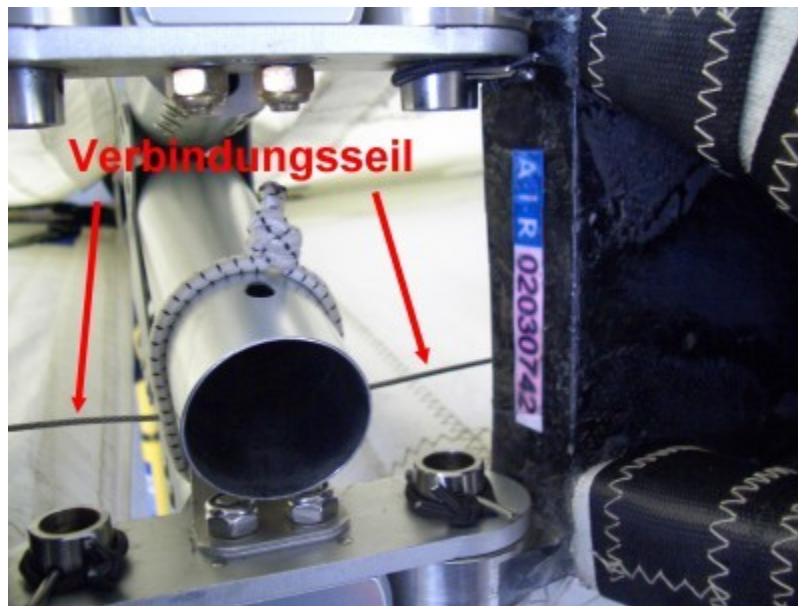
During bi-annual safety inspections at A-I-R, some gliders were found to have damaged circulation cables as shown in Picture 1

Picture 1 / Nose connection wire

This cable is easiest to inspect during set up before the glider is fully rigged. As a precaution the cable must be checked (optically) for kinks and broken strands. Alternatively it can be checked by feeling along the cable with a finger-nail. Note: The cable must not be removed for the check. (Picture 2 shows a damaged cable which must

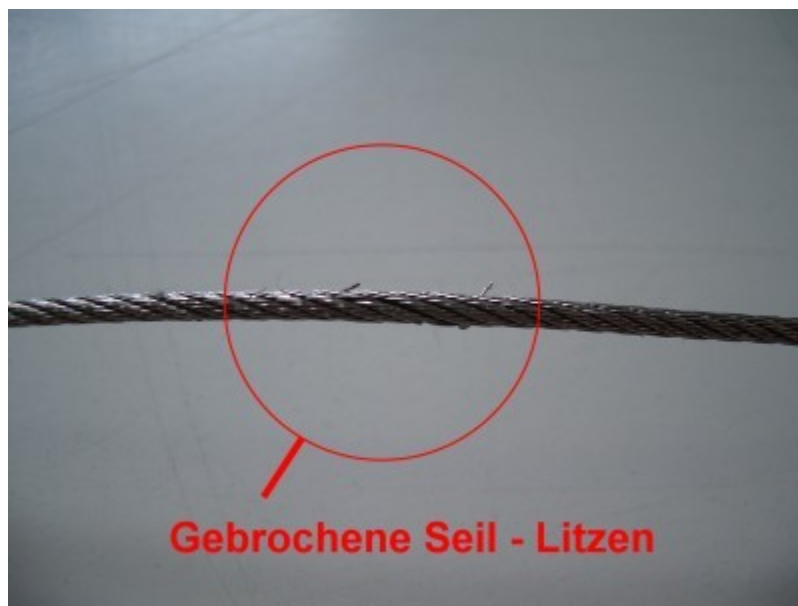
Picture 2 / damaged cable

be changed.)

Important: This is important and must be done before your next flight! Do not fly with one or more broken strands. (There may be further hidden damage.) The cable must be changed.

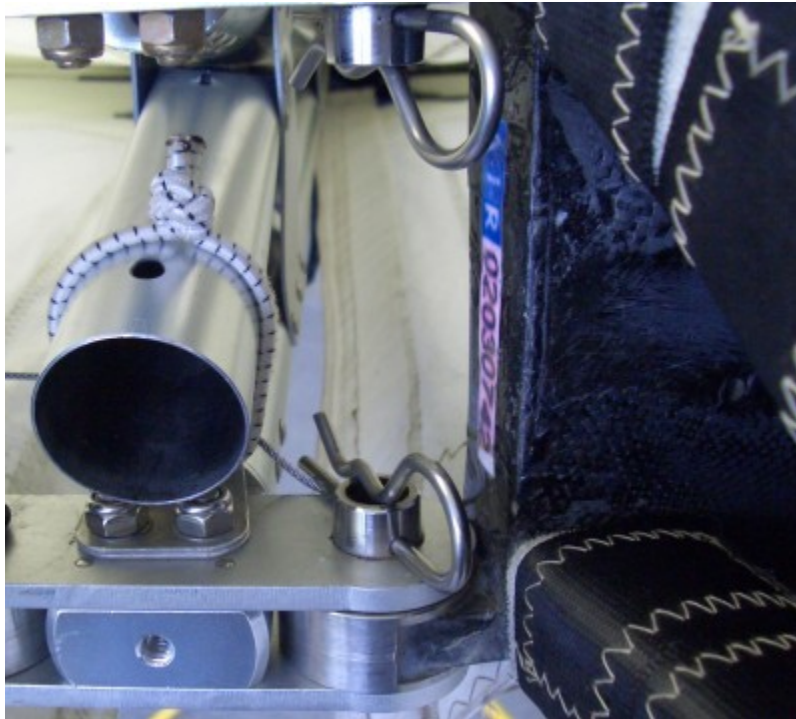
The cable can be damaged if miss-routed as is shown in **Picture 3**. This does cause symptoms of an unusually high cable tension when connecting the side wires and noisy movement of the A frame.

Picture 3/ Miss-routing of the cable.

Note: Miss-routing of the cable can only occur during rigging. It cannot occur if the glider is rigged correctly.

Take care: Do a pre-flight check as described in the manual. The whole length of the control cable should be checked

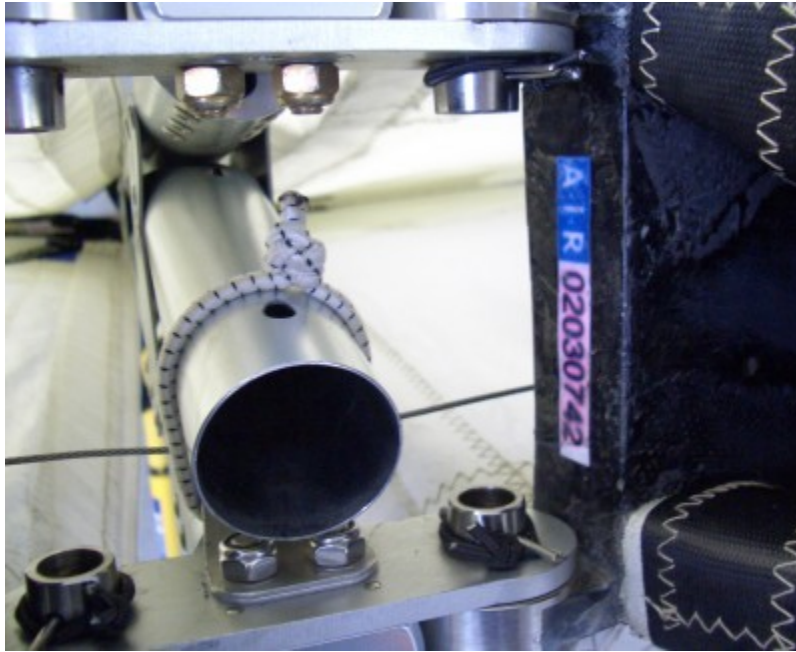
Picture 4 / New updated main bolt pins.

- 4 Replacement pins for the main bolts.
- 2 rope protection webbings which attach with Velcro around the D-spar.

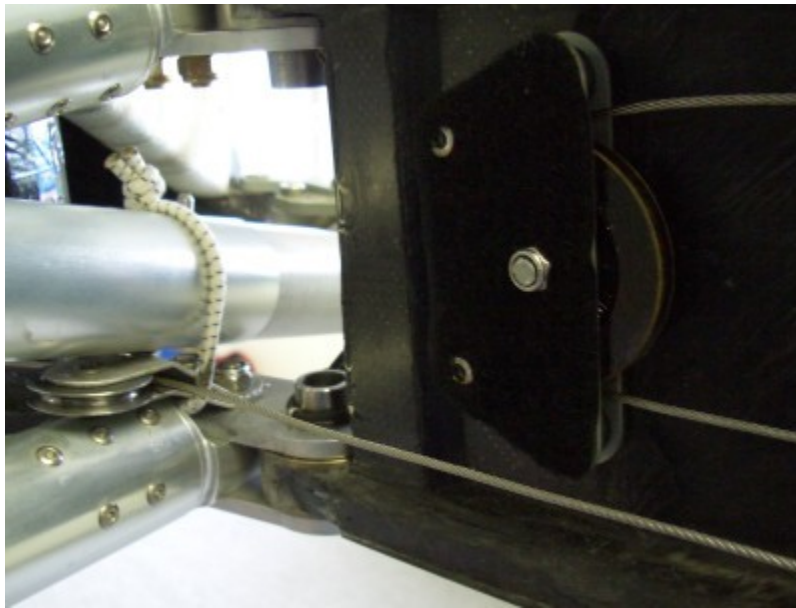
Picture 5 / Without rope protection webbing.

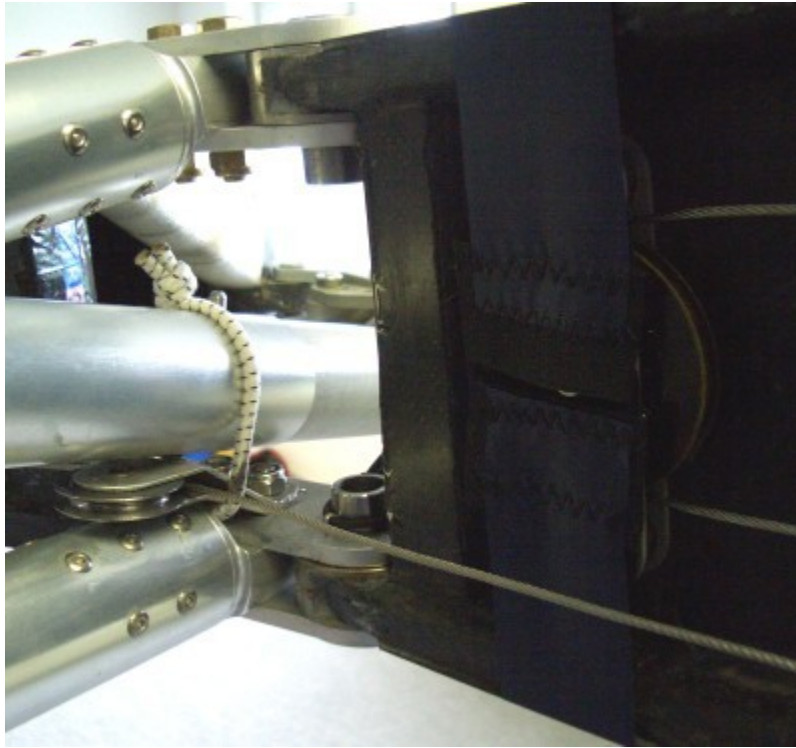
Picture 6 / Wire rope protection modification.
