Replacing the center wire in your ATOS

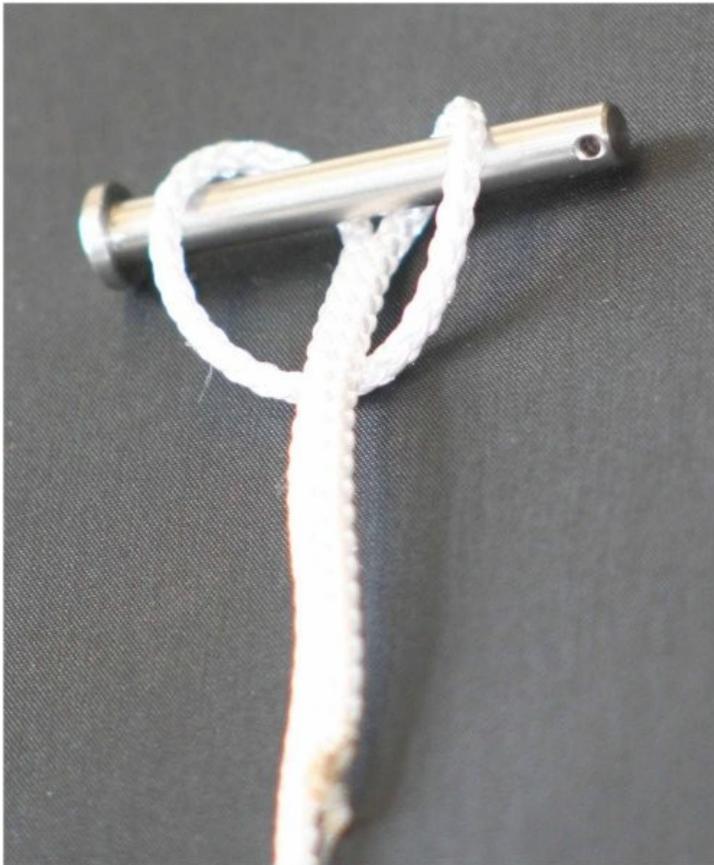
The center wire inside the nose of your ATOS that connects the two side/front wires apparently comes under a little too much stress around the small metal pulley right at the front end of the keel. If you notice that one of the strands of the wire has broken. If this is true this is an indication that other strands will soon be breaking and it is time to replace the wire.

Originally the ATOS models C, V, VX, and early VR, were shipped with a 2mm stainless wire. It was replaced with a 2.5mm zinc coated steel wire when premature wear was observed. The problem was work hardening of the wire across the nose pulley radius. The zinc coated steel was more flexible and has performed much better.

AIR recommends changing the wire with a Dyneema cord that they provide and use on all their new ATOS's. When you replace the cable with the cord you'll want to be sure to wrap the loops at the ends of the cord around the pegs in the barrels at pictured here:

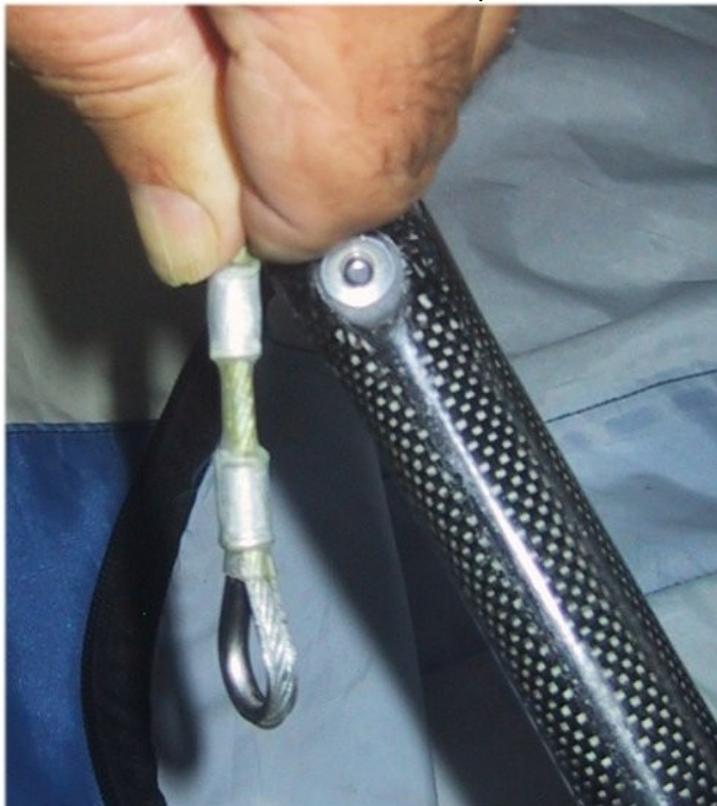
My particular Dyneema cord was 2" too long and this is what the side wire looked like when I first installed the new Dyneema cord:

It went way past the down tube pit pin. Bob Lane took 2" out of the cord for me resewing it. Then the side wires were very tight after this fix.

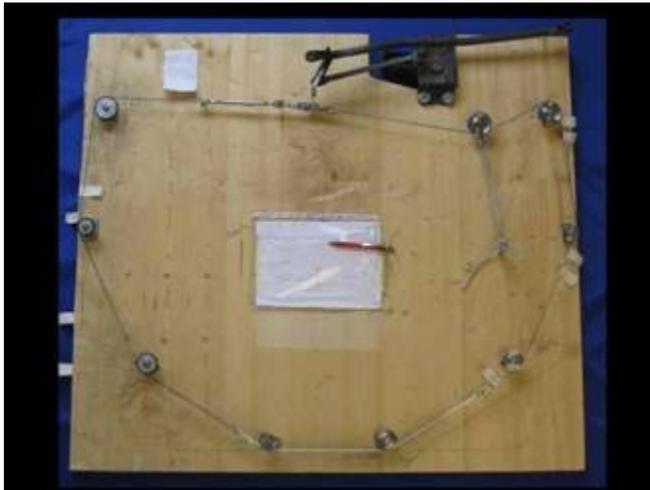
The Dyneema was tested along with both other steel wires through hours of cycles on the test bed picture below.

It provided for normal max loads and allowed the plane of the wires/dyneema to be slightly offset to the pulley such as might occur with a glider that has it's nose angle set incorrectly. This causes excess wear in that the line will then ride the edge of the stainless pulley. After many hours of continual cycles, the 2mm showed significant wear and broken strands. The 2.5mm showed wear consistent with an approximate 200+hr season with one broken strand while the Dyneema displayed minimal wear. The Dyneema runs smooth while the slow accumulation of wear is easy to observe and is consistent the failure mode of a 'rope' as opposed to the sudden failure of a steel wire.
